CREEKS, BROOKS AND RIVERS
IN
ROCKLAND COUNTY, NEW YORK
and
Their Relation to Planning For the Future

Gordon R. Ayer and F. H. Pauszek

UNITED STATES DEPARTMENT OF THE INTERIOR
GEOLOGICAL SURVEY

BULLETIN NO. 6

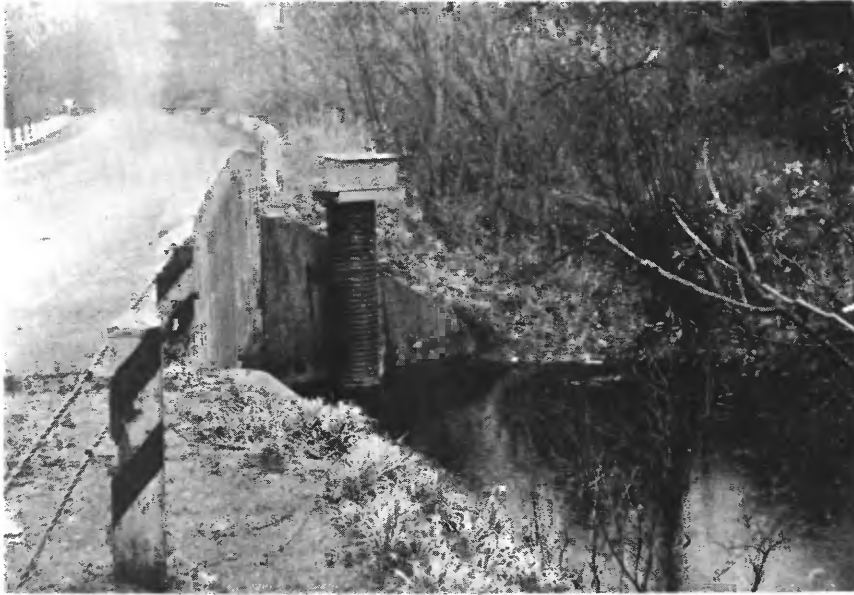
Gaging Station, Mahwah River near Suffern, N. Y.

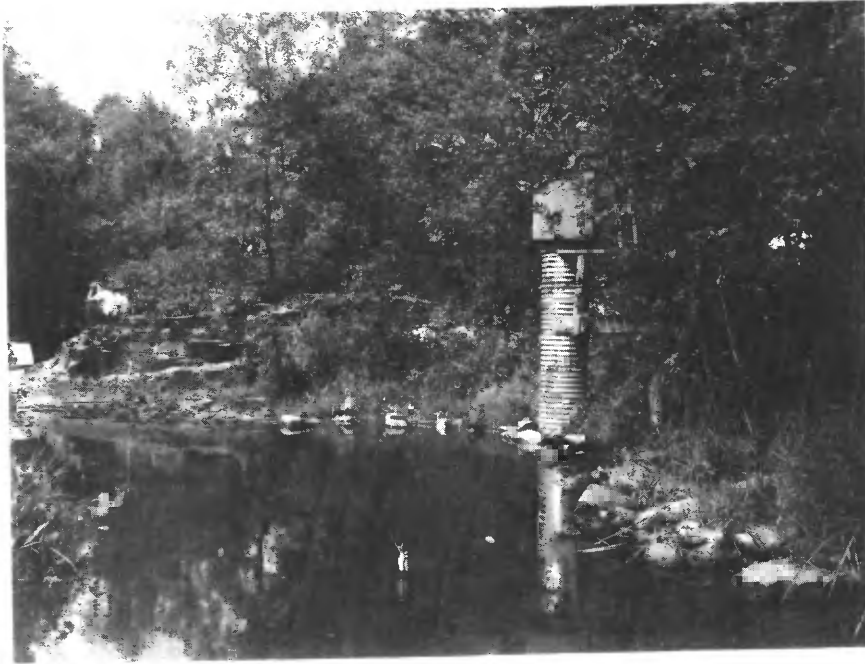
Typical Rockland County Stream-gaging Station
